## SHAFT SINKING AT WELLWOOD STREET FAS, AMBLE, NORTHUMBERLAND.

**Northumberland  
Water**

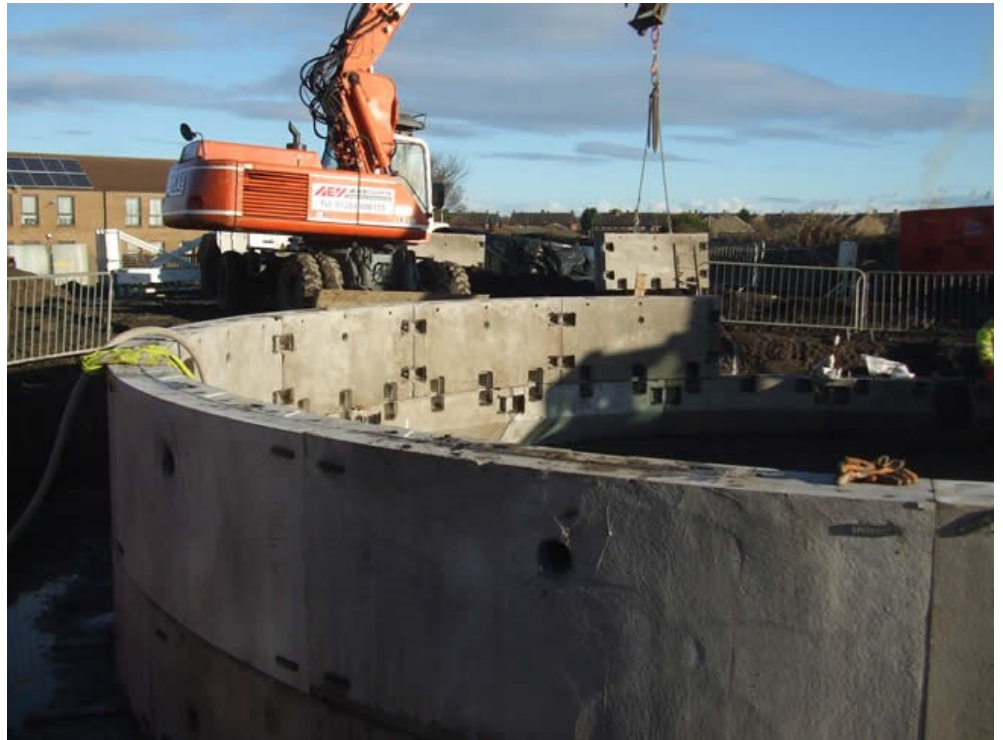
Shaft Sinking works underway at Wellwood Street, Amble

- 1 No finished 10.67m diameter x 9m deep caisson shaft.
- Well point dewatering

- Made ground, wet sand and gravel overlying firm clay to formation level.
