CULVERT REFURBISHMENT AT SHAW BROOK

Refurbishment of culvert whilst ensuring traffic flow on busy road remained unaffected

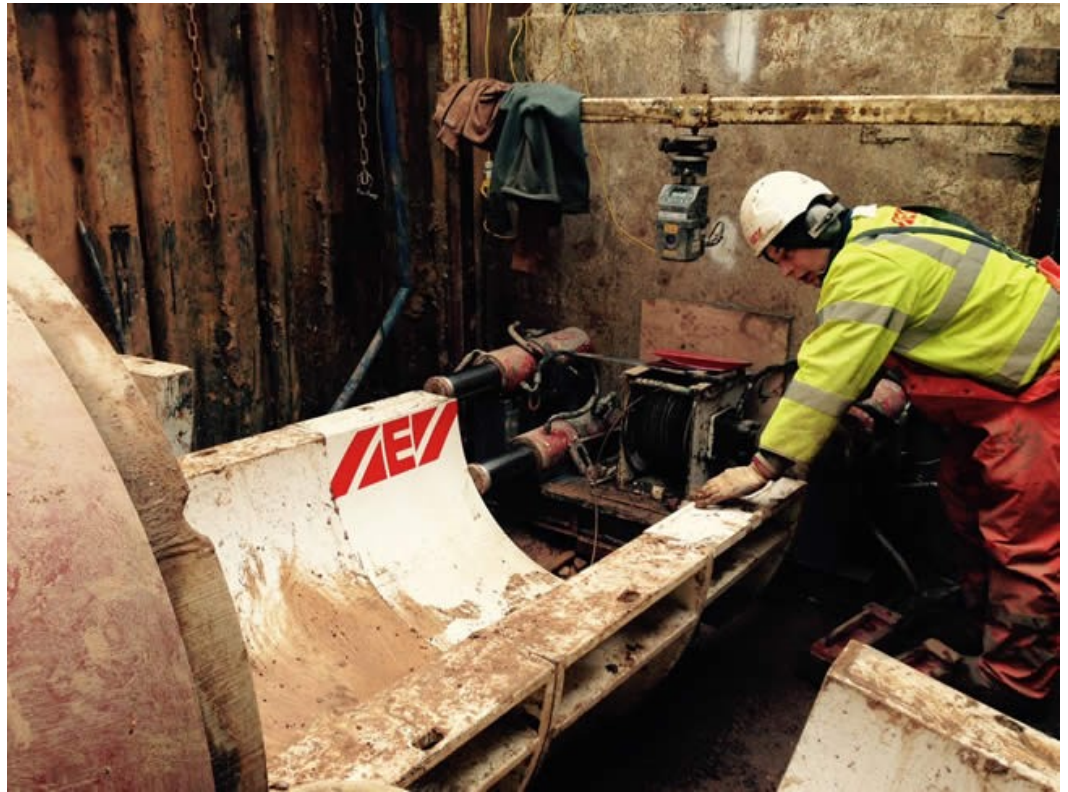
An existing surface water culvert that passes below the very busy Leigh Road in Boothstown was becoming dilapidated. In times of high rainfall the culvert surcharged and flooding of the upstream inlet area occurred.

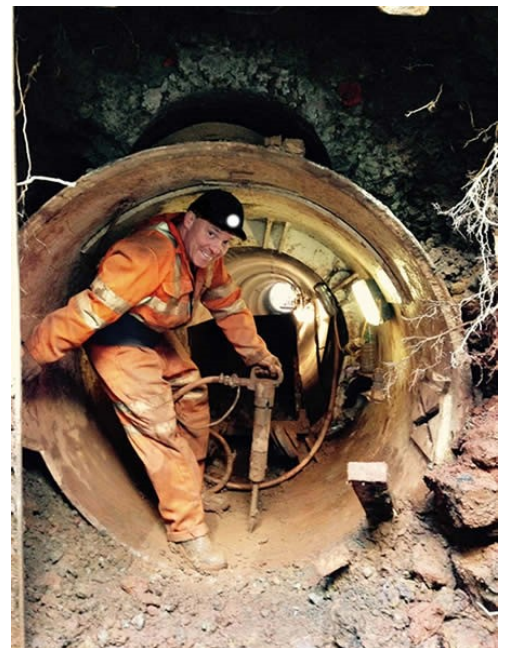
Due to the varied ground conditions we opted for a hand excavated pipejack to install 20m of DN1200 jacking pipes. The drive and reception pits were constructed using sheets and frame. Settlement monitoring of the carriageway was established and recorded no movement throughout the work. The remaining sections of pipe were laid in open cut and finished with PCC headwalls.
