PIPE BURSTING AT YMCA POSTLEY ROAD, MAIDSTONE.

Pipe bursting existing sewer and up sizing

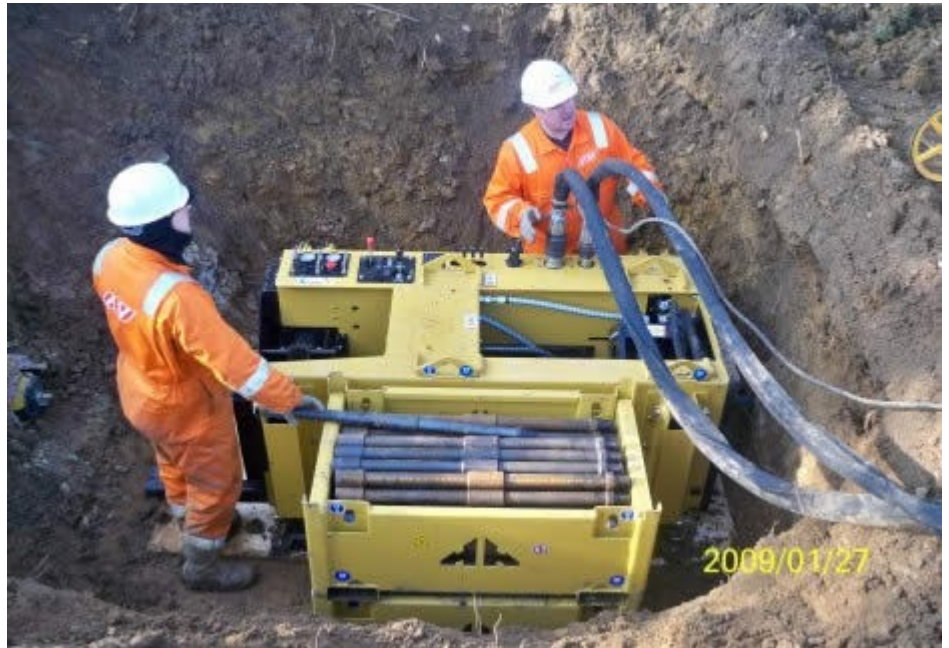
Pipe Bursting on site at YMCA Postley Road, Maidstone

The works comprised pipe bursting existing 225mm sewer and up sizing to accommodate a 355mm SDR 17 MDPE pipe. The section was split into two runs with intermediate manholes removed as they were to be rebuilt and the pipe was welded into two sections, 96m and 208m.

Using a 100 tonne bursting rig the pipe was pulled in with relative ease, despite the presence of a concrete cover on the existing pipe. During the works, it was essential that access was maintained along the private road so the working areas and site accommodation were tightly packed to minimise any disruption to the public. Following installation of the first 96m section, a CCTV inspection of the line was undertaken to check for gradient and flat spots. The pipe passed the inspection without incident. Other works included construction of 6 no new manholes and reconnection to existing system.
