CULVERT REPAIR AT HARWOOD BROOK CULVERT LINING AND RETAINING WALL, GREAT HARWOOD.

Repair existing stone
culvert

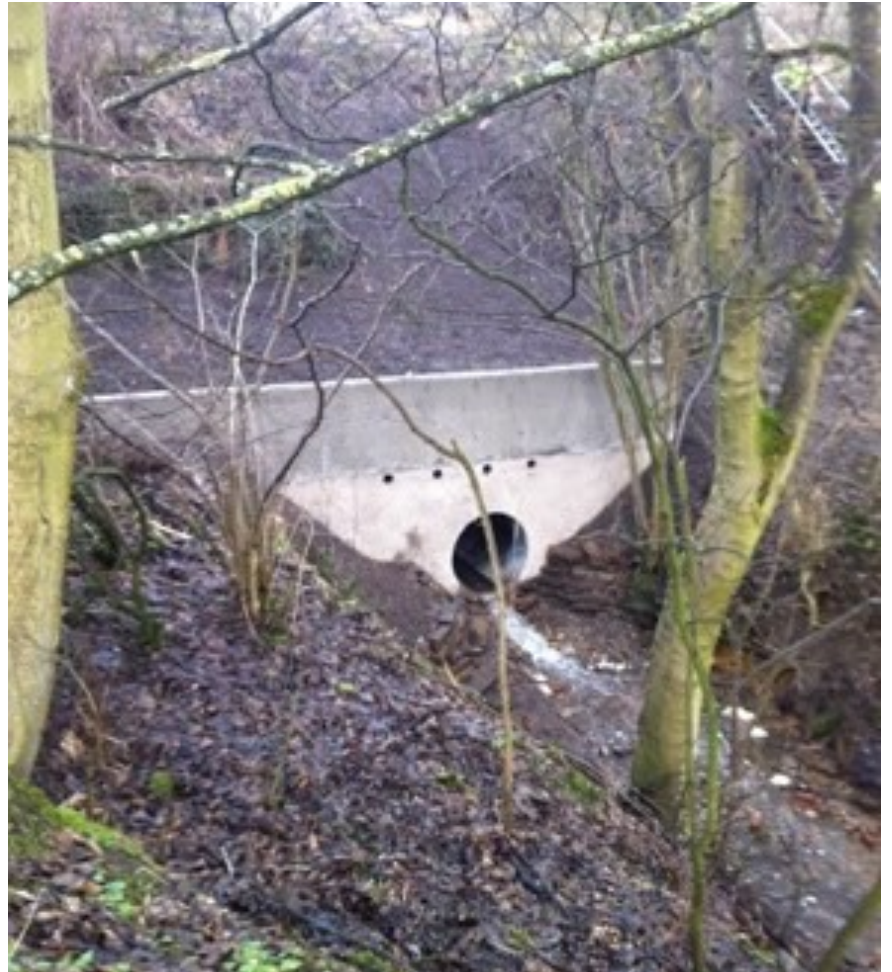
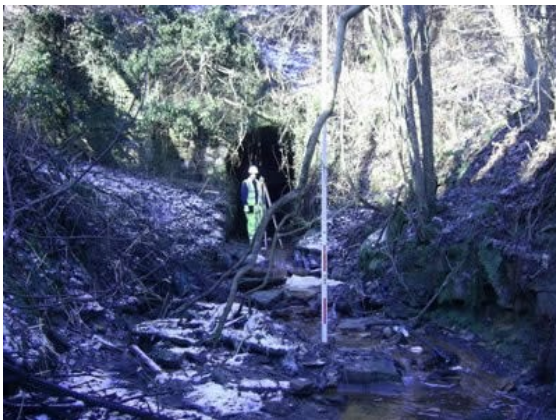
Repair of existing stone culvert and masonry retaining wall. Installation into existing culvert of 15m x DN1350 special coated steel pipe, followed by void grouting.

Construction of new RC retaining wall, 10m long x 3.5m high. Placement of 500m³ of selected fill.
