CULVERT REPAIR & RELINING AT HARWOOD BROOK, GREAT HARWOOD - MANHOLES B2 TO B3

Summary: Repair & reline existing culvert from manhole B2 to manhole B3

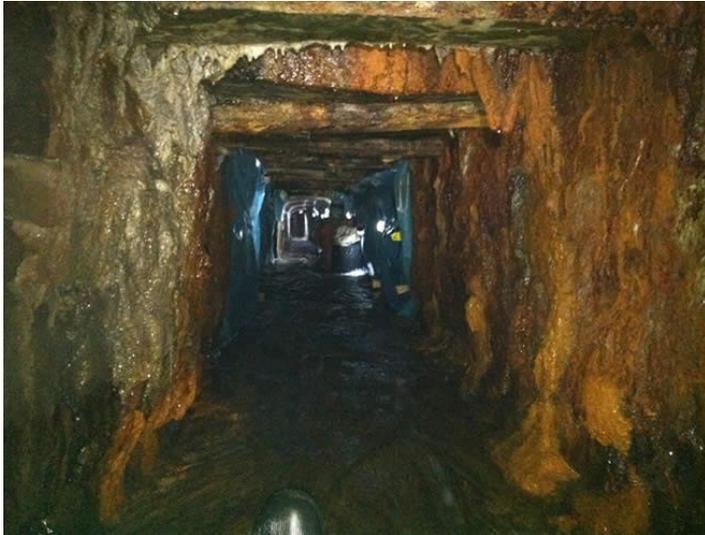
Before

Following CCTV and man entry surveys to assess the condition of the stone culvert it was noted that a section of the culvert upstream of B_MH2 was in a dilapidated state and required repair over a 63m length to bring it up to an acceptable standard.

The dilapidations consisted of many natural masonry soffit stones exhibiting mid point failure cracks and some being afforded support by badly corroded steel rail sections.
